**Brenda Villa Aquatics Center**  
City of Commerce  
Commerce, California  
**Air Quality Evaluation**

March 14, 2016

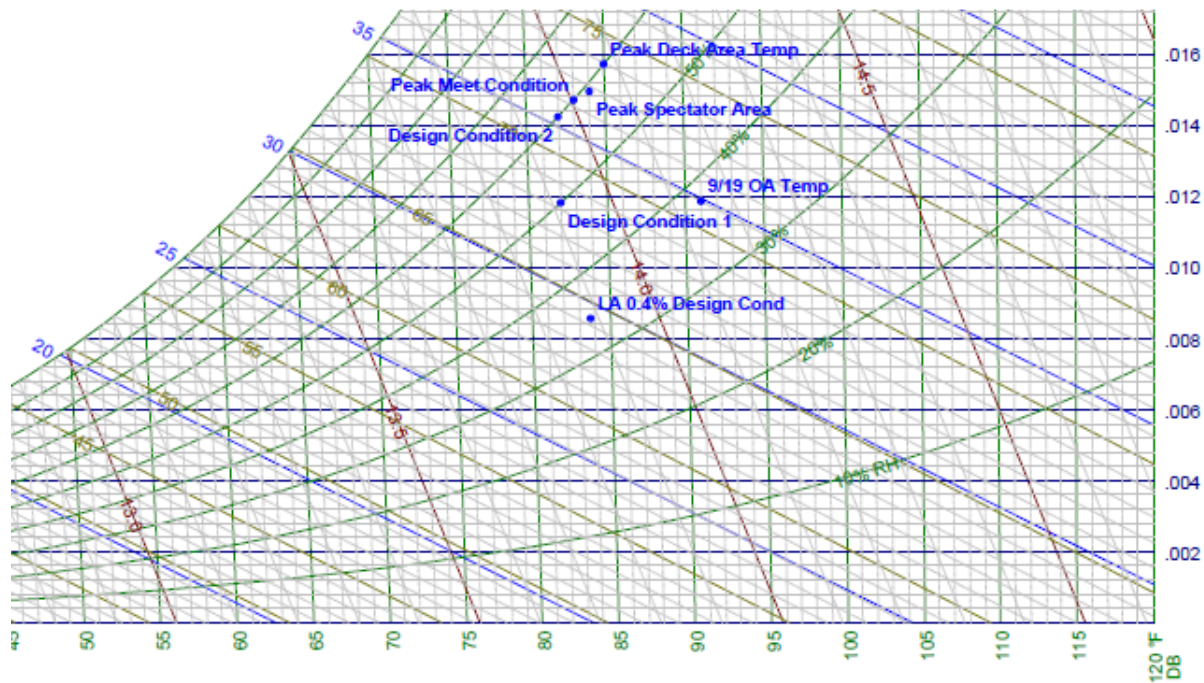
**Figure 4 – Peak Conditions and Design Conditions Psychrometrics**

As seen in Table 1 and Figure 4 the ambient air conditions are exceeding the design values. The highest readings for the pool area and spectator seating area were recorded during later periods when the set-points may have been higher. During the September 19, 2015 swim meet the highest conditions recorded were approximately 83 degrees, 60% RH in the spectator seating area and 84 degrees, 60 % RH at the pool deck. During this period maintenance personnel turned set-points down. While the system was not able to meet set-point it should be noted the indoor conditions were only slightly above the design condition even though the outside air conditions were significantly above design.

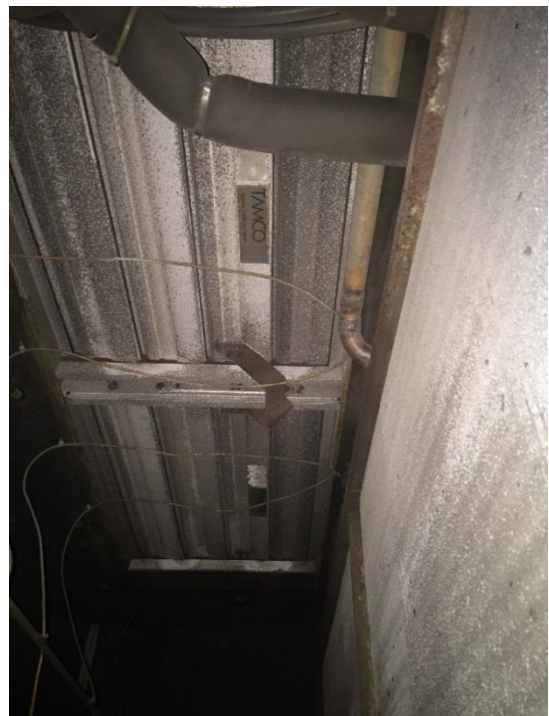
3. The outside air dampers for the de-humidifiers are closed or nearly closed. The dampers do not have automatic operation to allow the use of outside air for economizer operation when conditions permit.

**Dehumidifier outside  
air dampers in closed position**

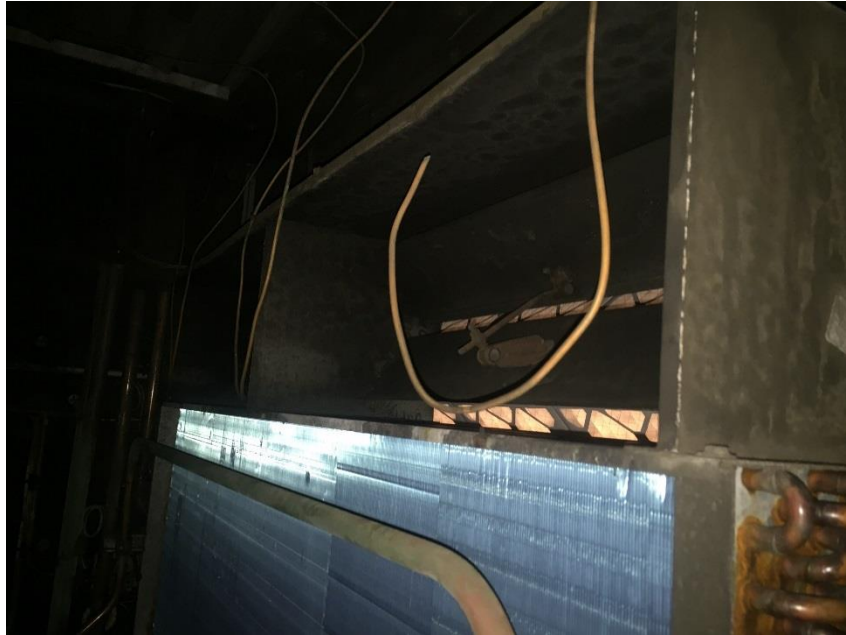
5. The dehumidifiers have bypass dampers around the cooling coils which are not operational but are locked in a partially open position. This is allowing unconditioned air to bypass the coil.

**Open bypass dampers around cooling coil**

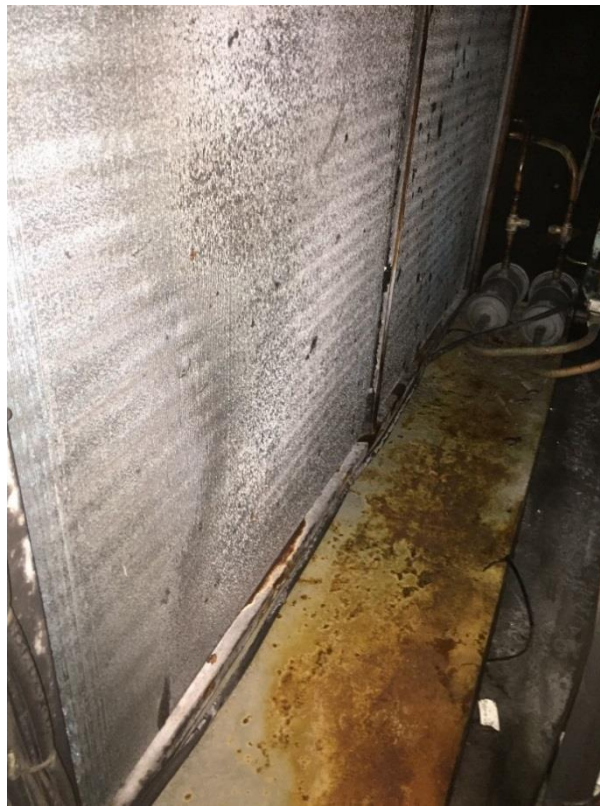
7. The dehumidifiers are able to meet space design conditions. This seems to be primarily due to the condition of the units and other deficiencies noted above. The units are showing signs of advanced age and are at the end of the life expectancy for this type of equipment. While the cooling coils appeared to be relatively clean both coils had a static pressure drop of approximately 1.3 inches w.g. indicating the coils may have fouling deep within the fins from the advanced age. A review of the data logger information indicated the lowest discharge temperature recorded off the coils was 53.1 degrees. The coils were designed to have a discharge temperature of 45 degrees. The broken bypass dampers may be partially responsible for this higher temperature but readings were taken near the center of the coil. The coils and compressors may not be producing full capacity due to the advanced age.

**Interior rust, deteriorating coil fins**

1. Replace each of the two de-humidification units. The new units should include outside air economizer function. This will require new mechanical rooms be created on the north end of the building. One possibility may be relocating the exterior condensers and opening the north wall of the mechanical room allowing expansion to the north. This is an expensive repair due to the extensive general construction that is required to accomplish installation of new units. While expensive this will eventually need to be done as the units are already near the end of expected life and are not currently meeting design conditions. **Approximate Cost = \$3,000,000 - \$4,000,000.**

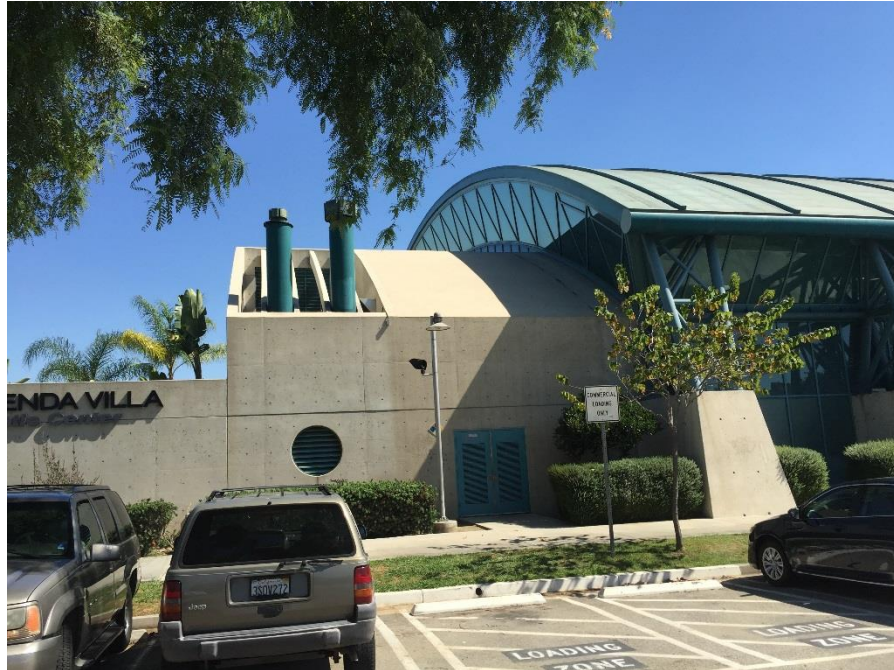
10. The existing de-humidifiers were installed in mechanical rooms surrounded by cast-in-place concrete walls. The roof of the mechanical room is concrete as well. The louvers to the rooms are not large enough to move new equipment through. The existing mechanical rooms are also small and must be accessed through a ladder and small trap door in the floor.

**View of northwest corner of building showing concrete walls and rooftop mechanical room**
