REPORT OF FOUNDATION DISTRESS INVESTIGATION
AND REPAIR RECOMMENDATIONS

For
Veteran's Memorial Park Recreation Building
6364 Zindell Avenue
City of Commerce, California

Subject: Report of Foundation Distress Investigation and Repair Recommendations
Veteran's Memorial Park Recreation Building
6364 Zindell Avenue, City of Commerce, California

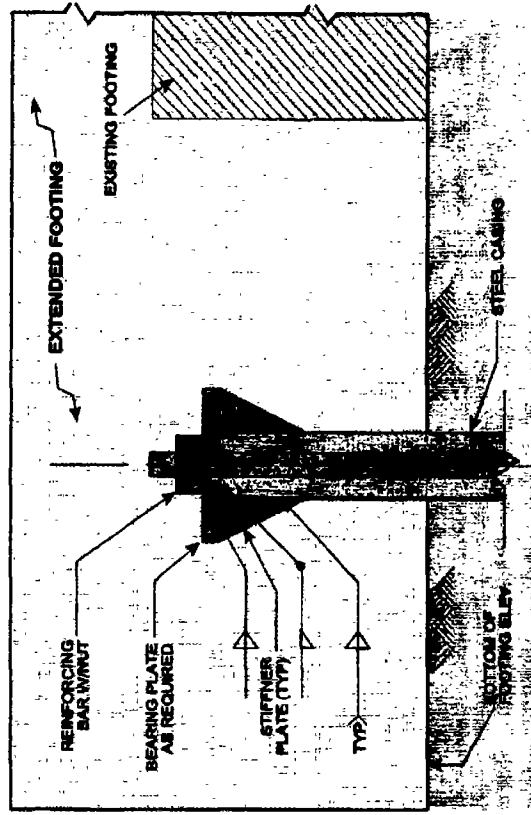
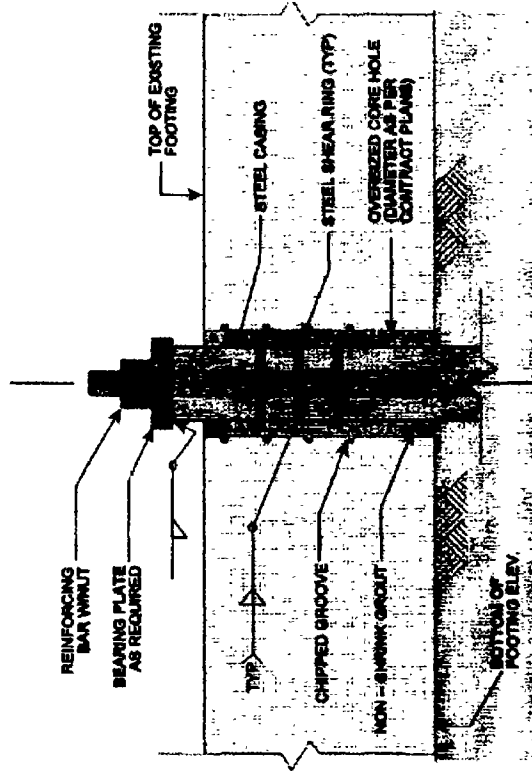
(For micropiles installed outside of the perimeter of existing footing.)

(For micropiles installed within the footprint of existing footing.)

Figure 5, Typical Micropile – Footing Connection Arrangements, illustrates the general connection detail between installed micropiles and the existing footings. It should be noted that, depending on area accessibility and constraints and magnitude and complexity of structural loading, different micropile – footing connection arrangements may be selected for different applications. In general, footings that are easily accessible from ground surface may be supported by micropiles installed outside of footing perimeter together with an newly extended/enlarged footing structurally connected to the

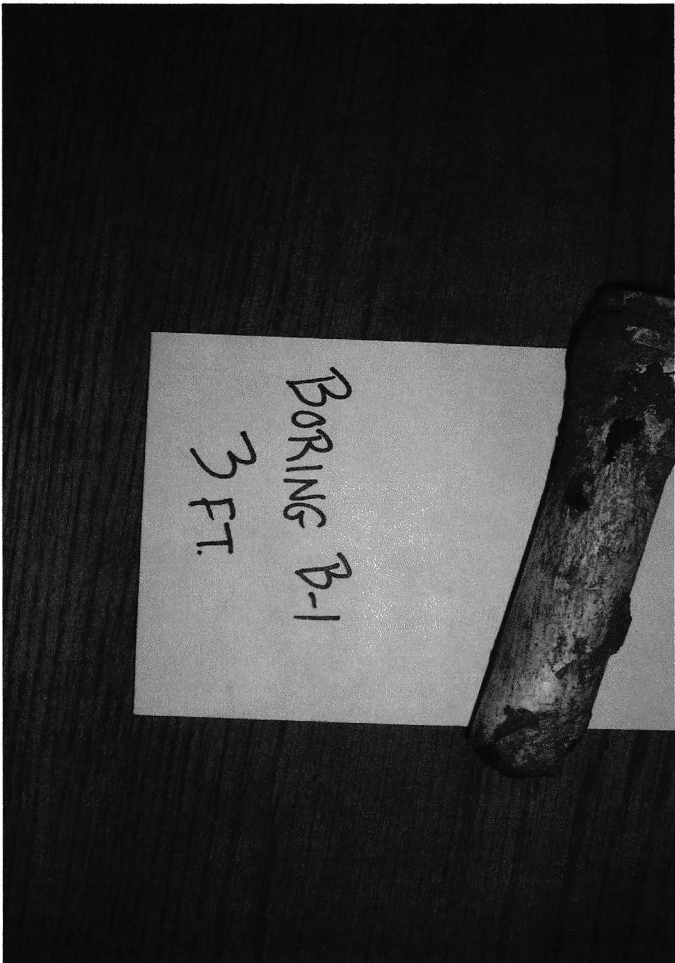
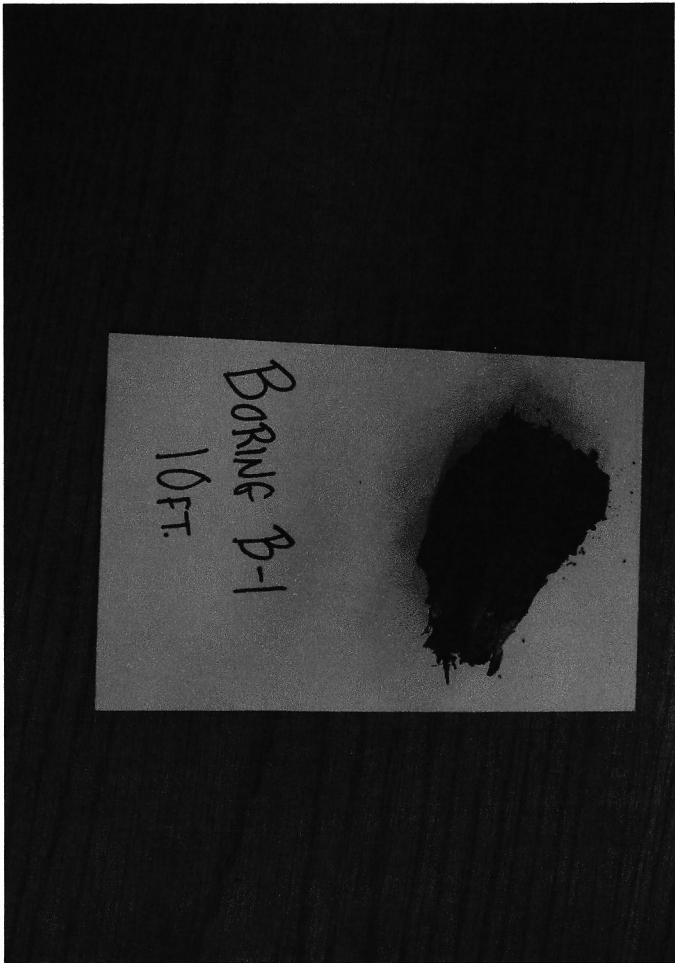
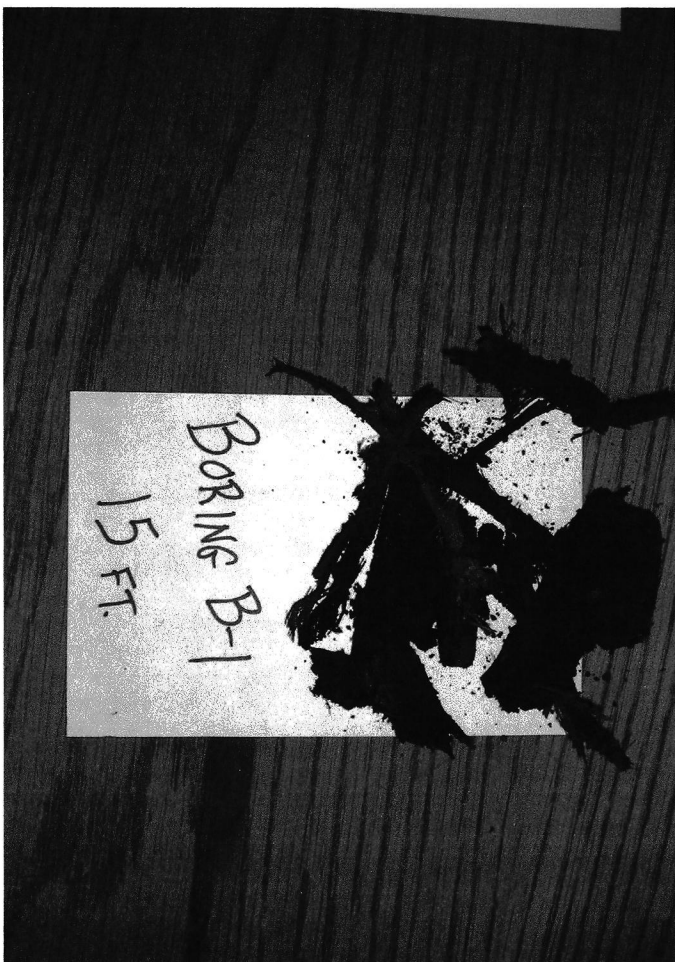
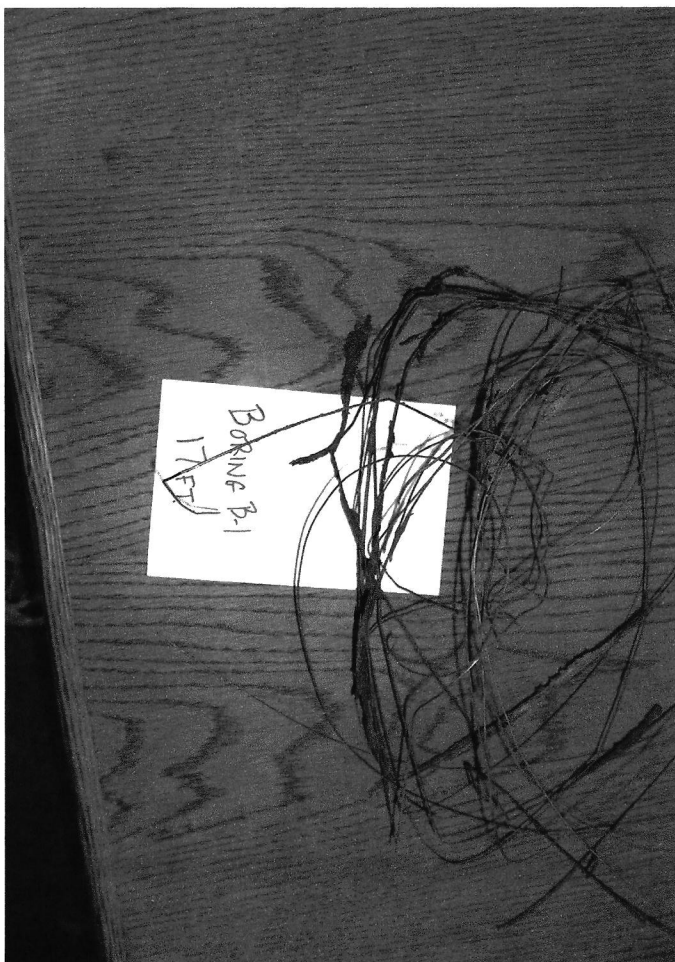
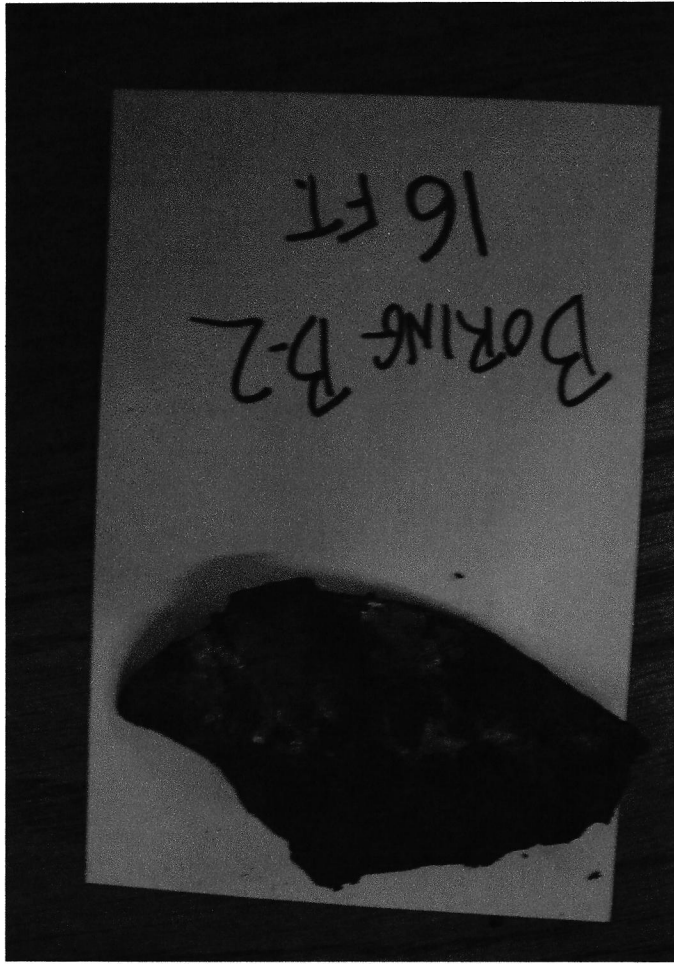
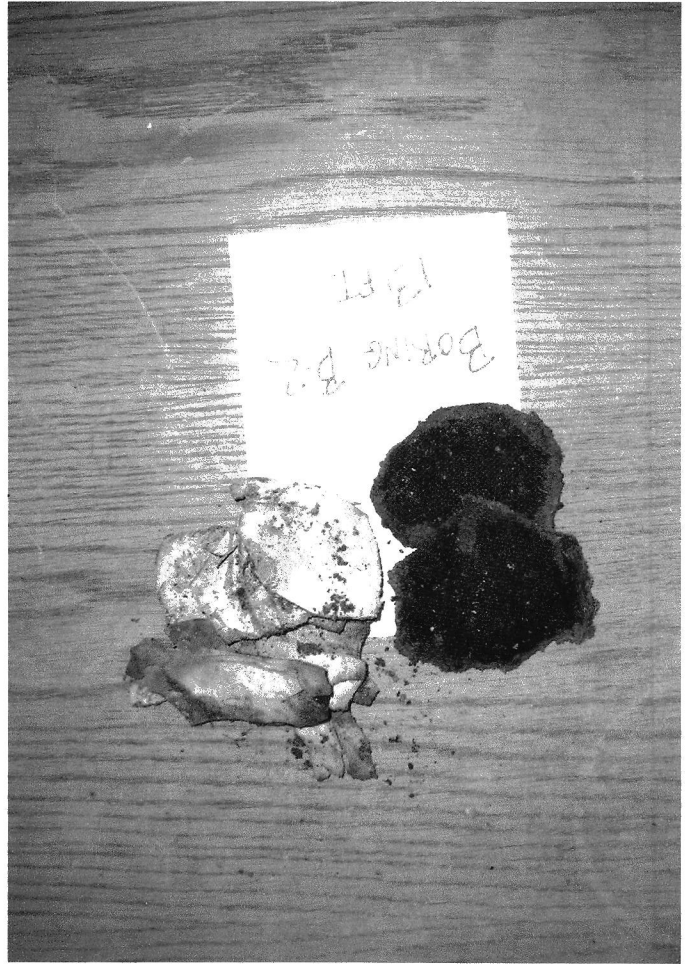
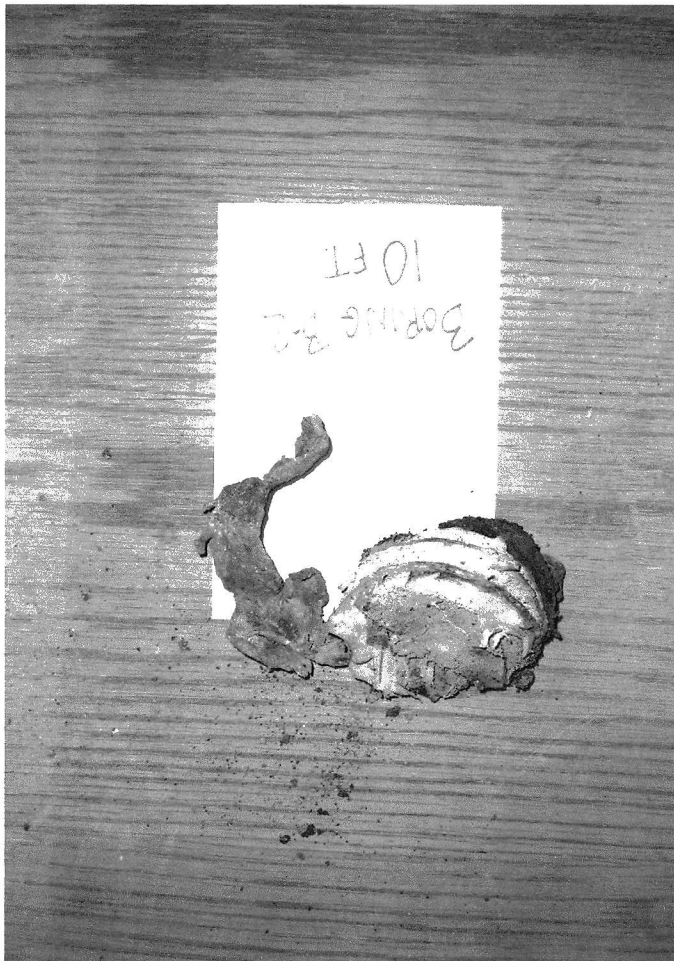
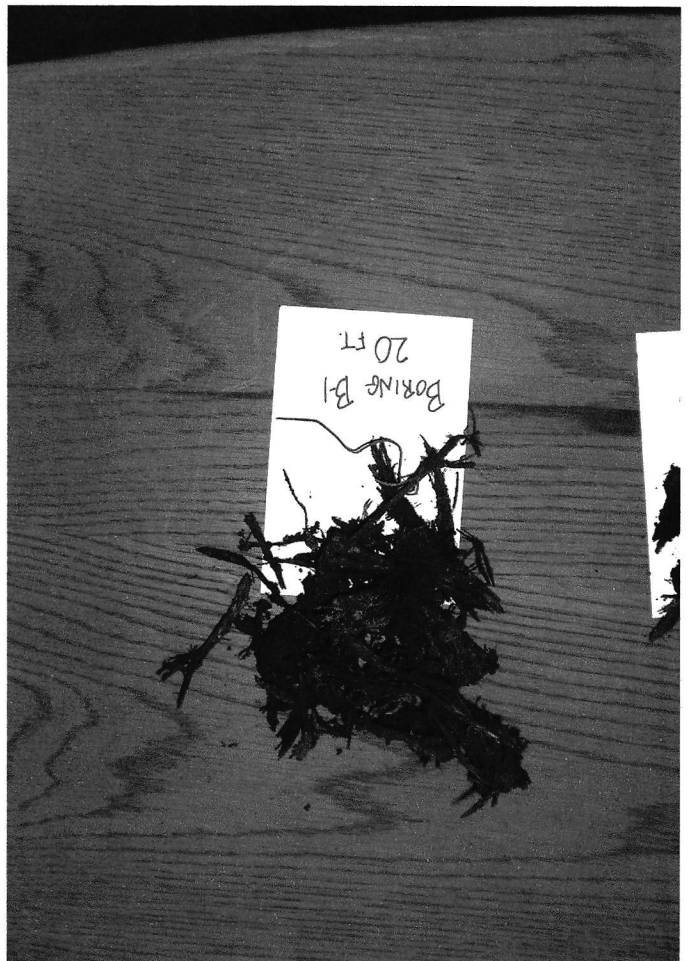
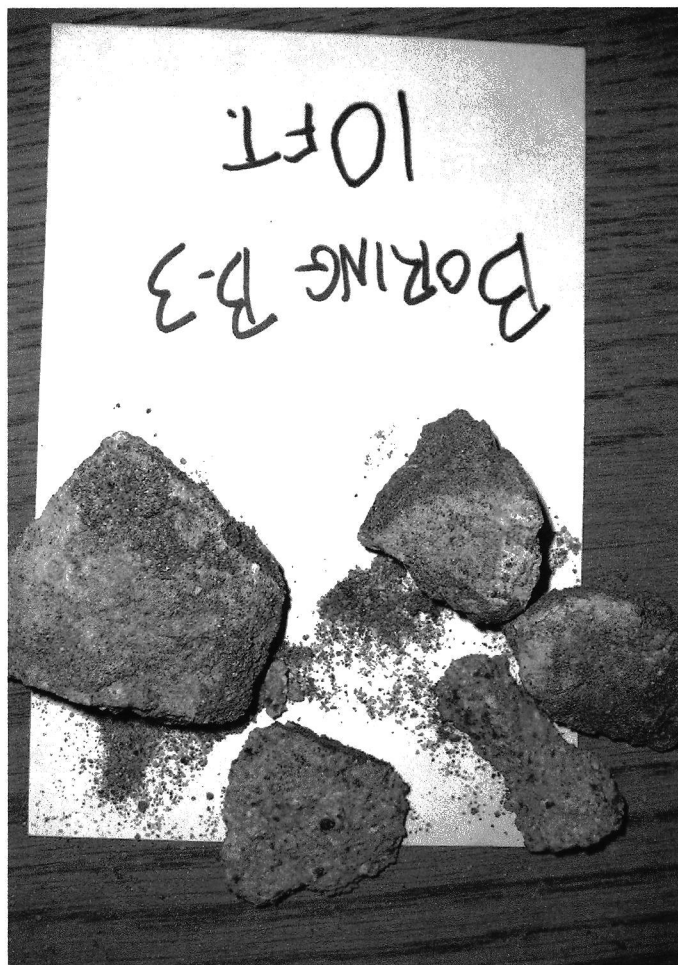
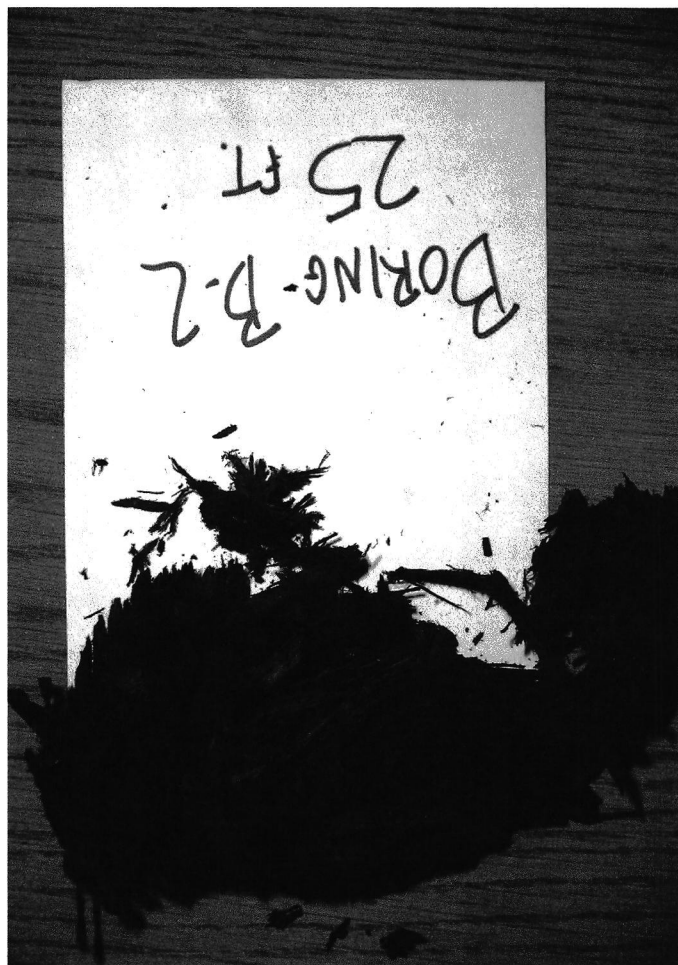
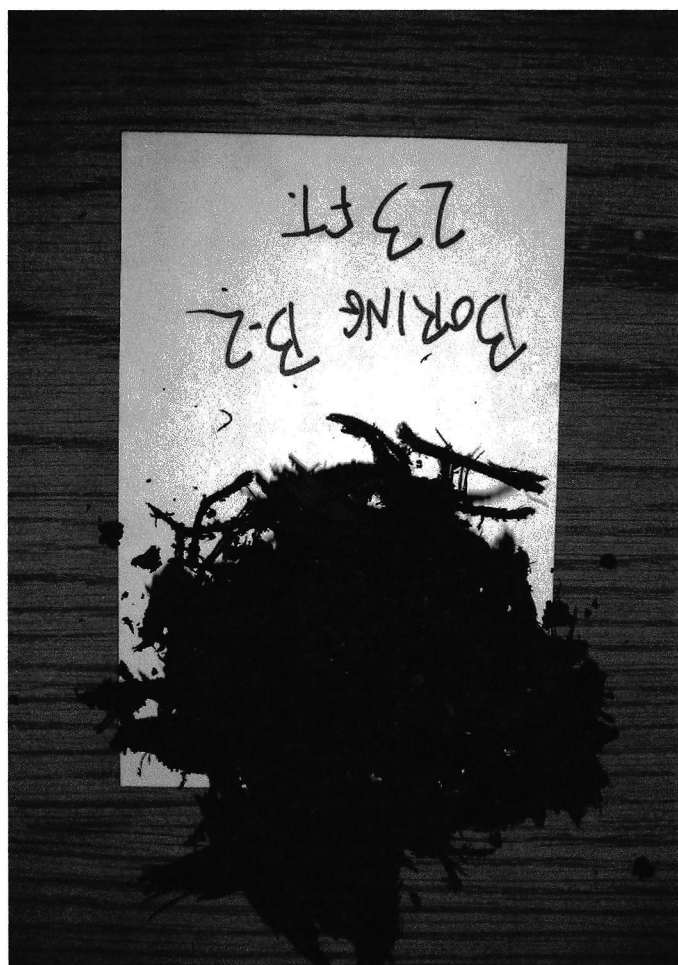
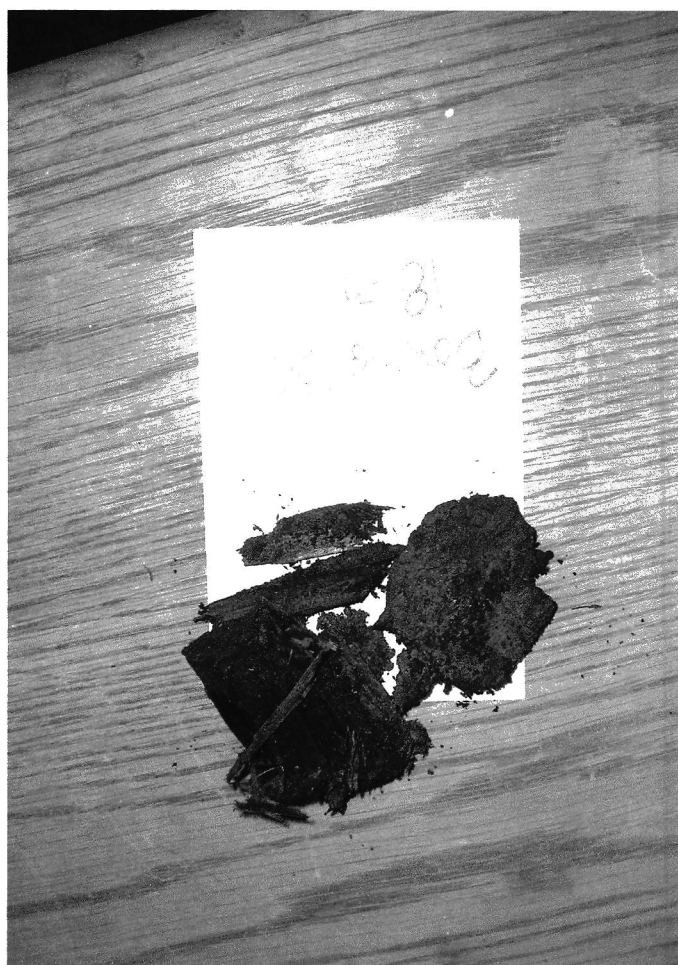
PHOTO EVIDENCE OF DEBRIS FILL

Immediately beneath the upper artificial fill layer in each exploratory boring was artificial fill of sand, silt and clay containing significant amount of trash and debris ranging in thickness from about 9 feet in Boring B-3 to 25 feet in Boring B-1. Debris fill consisting mostly of trash in a soil matrix was present below depths of 9.5 feet in Boring B-1 and 15 feet in Boring B-2. In addition to noticeable organic odor, the debris fill layer was found to be highly heterogeneous, porous and moist, exhibiting a loose to medium dense density in its present state. Photos of samples containing debris retrieved from the exploratory borings are shown in Appendix D, Photo Evidence of Debris Fill.

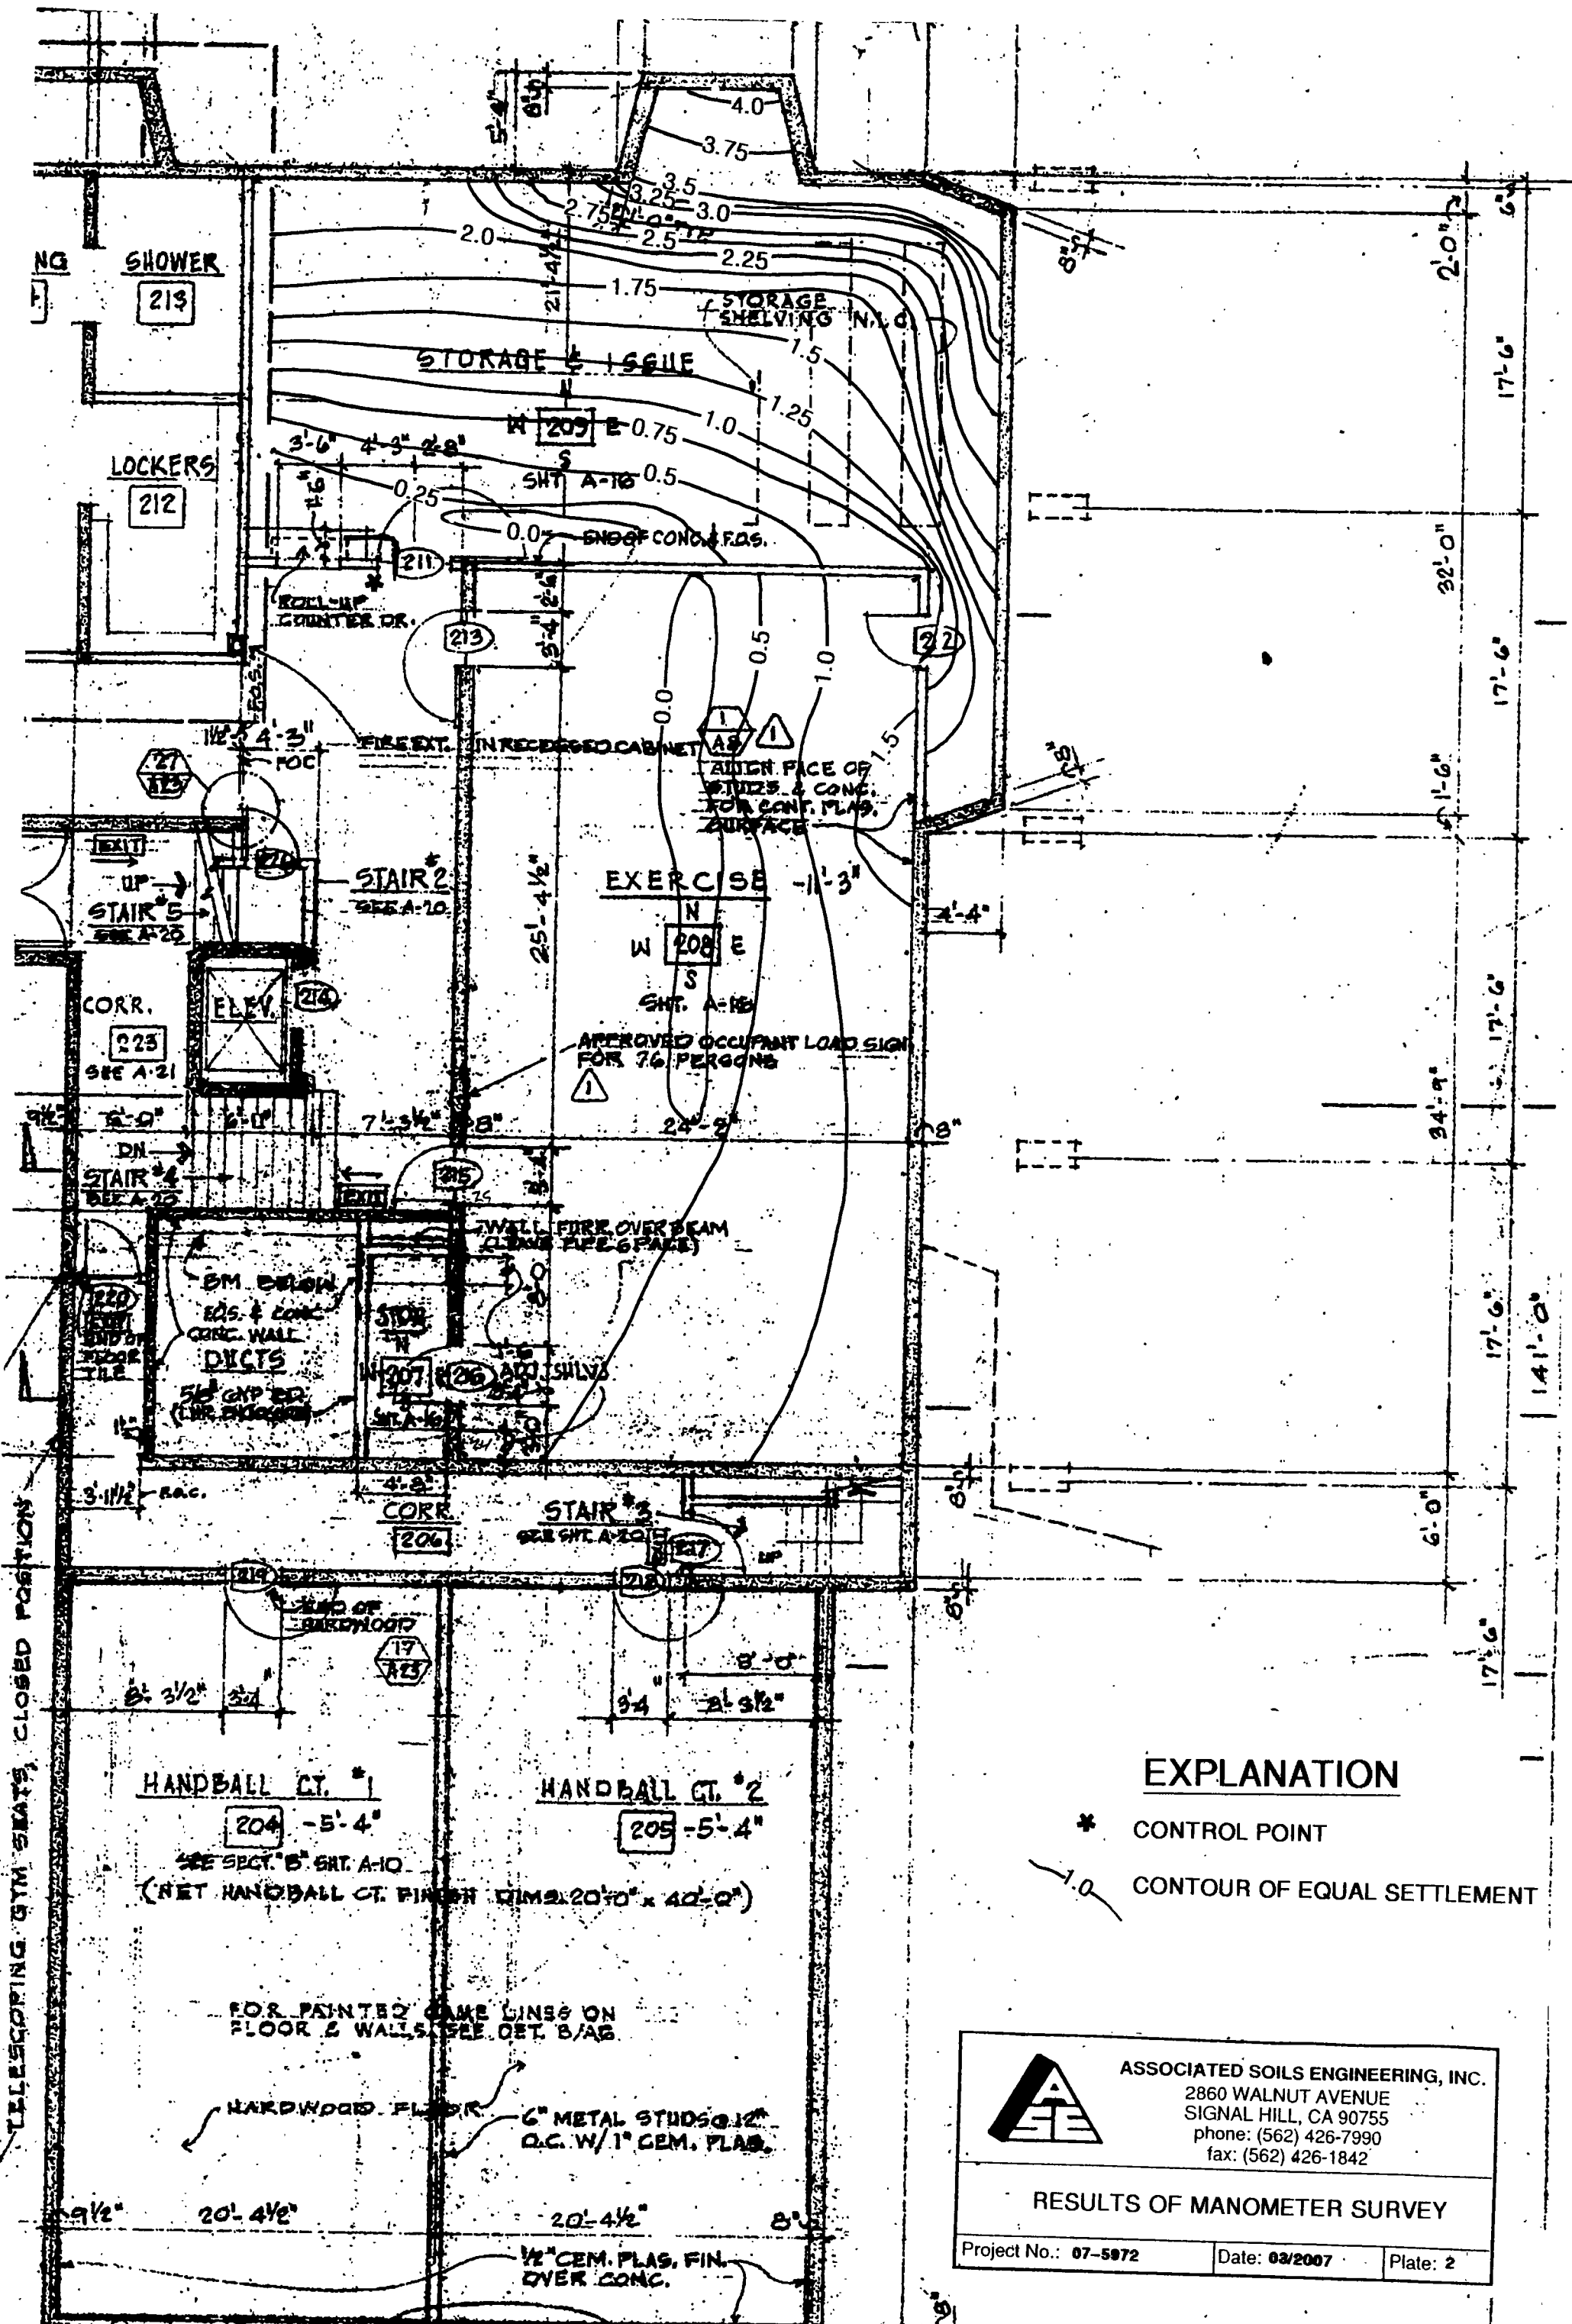
Borings B-1 and B-2. As less debris fill was encountered in Boring B-3 located to the east of the Building footprint (i.e. up to 12.5 feet deep from existing surface grade), the magnitude of differential settlement was also found to reduce to around 1 inch, signaling that 1) the significant settlement experienced at the Building has been adversely impacted by the presence of highly heterogeneous and loose debris fill, and 2) the scale of differential settlement recorded at different areas within the Building appears to be in direct proportion to the local thickness of the underlying debris fill. As such, any mitigative measures planned for the distressed foundation repair should either modify/replace the undesirable debris fill thoroughly and replaced with engineered, compacted fill, or relieve/separate the foundation bearing from the settling debris fill, or both.

- * CONTROL POINT
- 1.0 CONTOUR OF EQUAL SETTLEMENT
