# Brenda Villa Aquatic Center Air Quality Evaluation

# Air Quality Evaluation

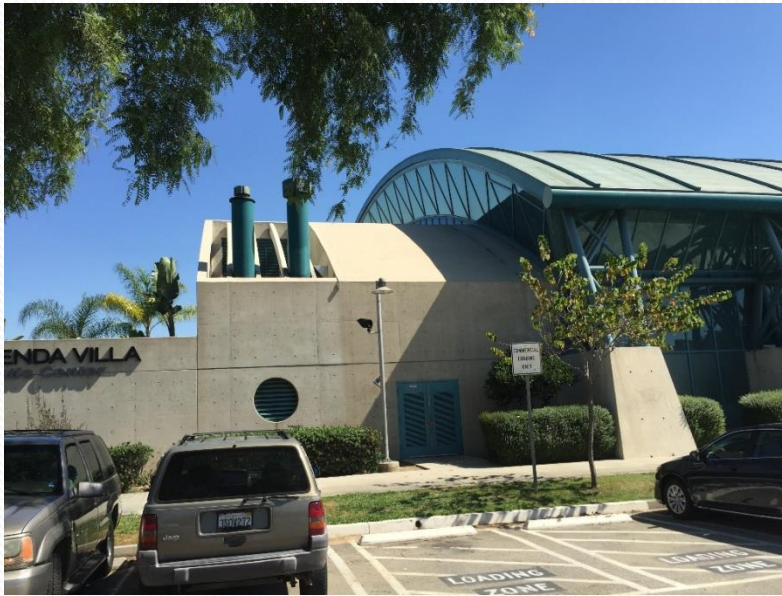
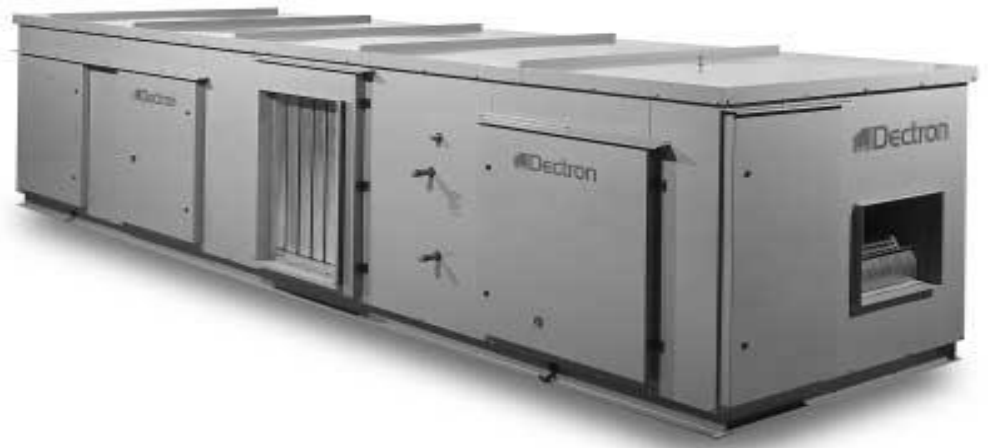
# Mechanical Room Access Issues – encased in concrete

- Mechanical room – poured in place concrete structure around all equipment including the DH units. They are located on the 2<sup>nd</sup> floor and access is through a small 3'x3' opening in the ceiling on the ground level.

DH Unit – 12'7" L x 7' w x 8' h –  
the pool area uses two such units
