ASSESSMENT OF THE VETERANS PARK COMMUNITY CENTER AND ALTERNATIVES FOR A CITY INDOOR SPORTS FACILITY FOR THE CIVIC CENTER

FOR THE CITY OF COMMERCE May 1, 2017

BY TRANSTECH ENGINEERS INC.

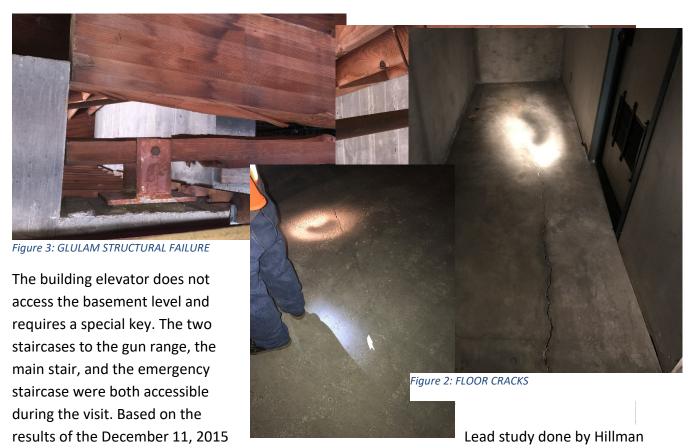
Consulting, it is determined that the Veteran's Park Community Center Building is still viable as long and abatement is successfully completed for two thirds of the building as prescribed. During the visual inspection. It was noted that a major structural glu-lam beam had failed in the northeast corner of the building. The failure resulted from settling of the building in this corner, probably due to differential settlement of the foundation. The settlement of the foundation is evidenced by a sloping floor slab at the main level and numerous cracks in the walls and floor slab at the basement level (FIGURE 3). There are also numerous issues throughout building that allude to structural competency of the building elements. Examples of this include FIGURE 4: A failed ledger holding up ceiling joists, FIGURE 5: Loosened bolts on a structural connection, and a porous concrete ceiling at the shooting range.

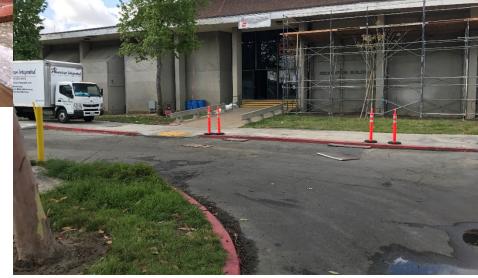
Figure 5: DISABLED ACCESS BARRIERS AT ENTRANCE

In addition to the structural issues around the building, there are numerous disabled access barriers that will need to be addressed if this building is eventually re-used for any purpose. The building entrance is sloped upwards from the parking lot and has a set of stairs in the front of the building. This means that the entrance will have to be reconfigured to provide a

disabled access ramp to allow access and egress from the building. Once inside, the accessible path of travel will need to be upgraded to every part of the building. This means that a new

elevator will need to be installed that meets current ADA regulations as well as provide access to the basement, which it currently does not.

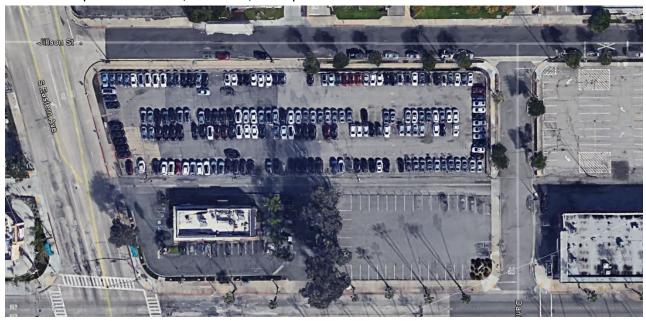
Figure 7: JILLSON SITE

These two sports facilities sites and buildings are included in the comparison from a previously conducted feasibility study in December 2016, by HED Consultants. The cost estimates were included without adjustment because estimate was recent. It should be noted that the space planning requirements for a new indoor sports facility were taken directly from this study. Thus, the needs assessment for existing warehouse space and the sizing of a proposed Sprung building used an average floor are requirement of 36,000 to 40,000 square feet.

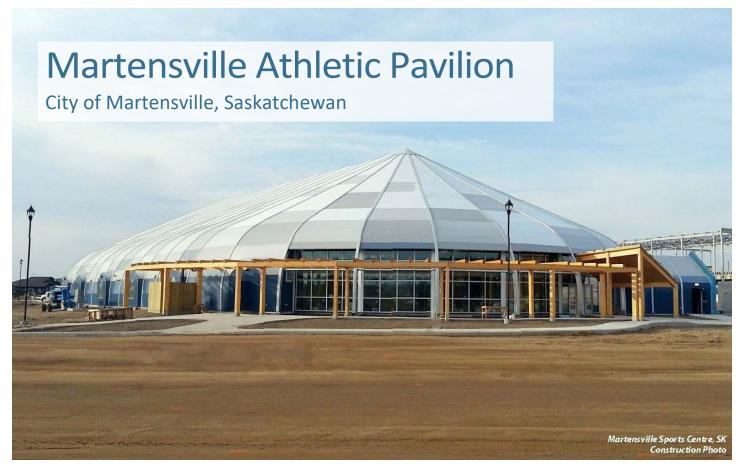
140' wide x 290' long Sprung Structure The City of Martensville, Saskatchewan,

In the fall of 2013 construction started on the 140' wide x 290' long insulated Sprung structure, which was erected and enclosed quickly so that the interior of the building could be worked on whilebeingprotected from the outside elements.

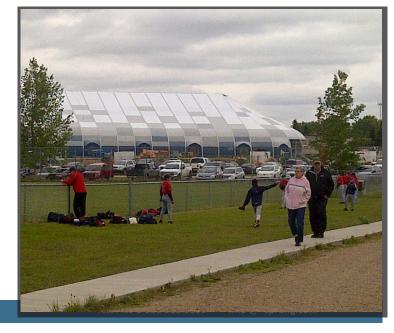
In the fall of 2014, the Martensville Athletic Pavilion (MAP) opened its doors to the high school and the community. The facility boasts 3 hardwood courts all of which can be separated with the 2 drop down curtains. The floors can be converted to a full or partial soccer field with the soccer flooring that can be added or removed in 3 hours. The MAP also has an elevated 200 meter curved running track, fitness area, dance and yoga studios, multi-purpose space, offices and concession stand. The Sprung structure exterior membrane includes custom translucent daylight panels which are strategically placed to add additional natural daylight over the playing surfaces. With the money saved not having to build a gymnasium inside the high school, the city was able to also build a 500 person theatre that is used for the high school during the day and the community in the evening.
