Subject: Veteran's Memorial Park Recreational Center Improvement Project

Subject: **Proposal for: 1) Limited Geotechnical Investigation and Retrofit Recommendations (inclusive of 2016 CBC Update) for the Existing Recreation Building; and 2) Supplemental Geotechnical Investigation for an Alternative Sprung Structure to be constructed on Veteran's Memorial Park Premises**

Veteran's Memorial Park  
6364 Zindell Avenue, City of Commerce, California

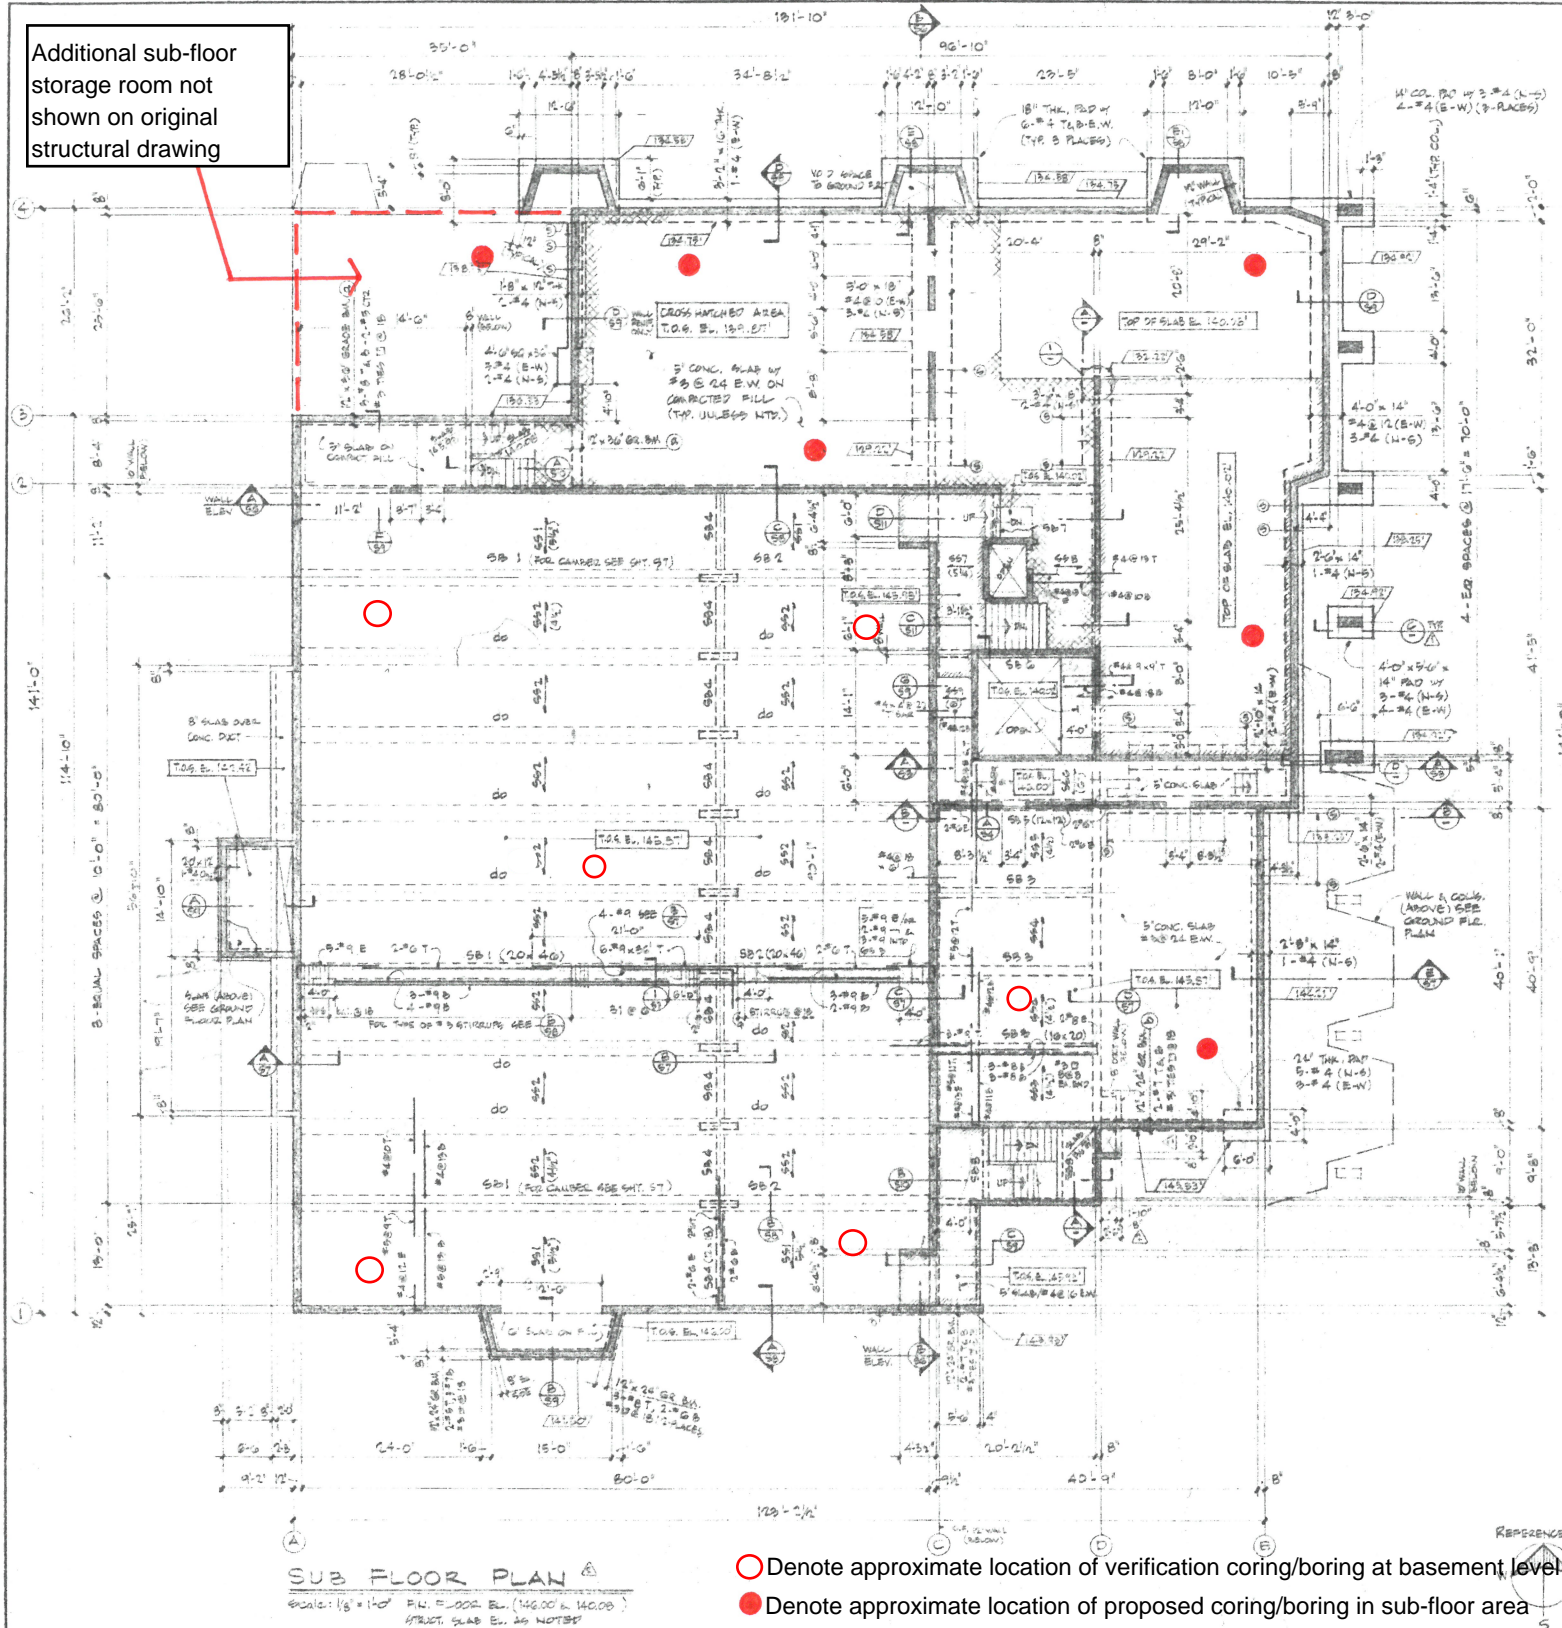
**Exhibit 1 Proposed Boring Location Map**  
 (excerpted from Sheet S2 of Reference 3)

Additional sub-floor storage room not shown on original structural drawing

approximate coring/boring locations within the Building are shown on the attached Proposed Boring Location Map, Exhibit 1. The exploratory boring locations for the Sprung Structure will be determined upon confirmation of the location by the City.
