REPORT OF FOUNDATION DISTRESS INVESTIGATION
AND REPAIR RECOMMENDATIONS

For
Veteran's Memorial Park Recreation Building
6364 Zindell Avenue
City of Commerce, California

Subject: Report of Foundation Distress Investigation and Repair Recommendations
Veteran's Memorial Park Recreation Building
6364 Zindell Avenue, City of Commerce, California

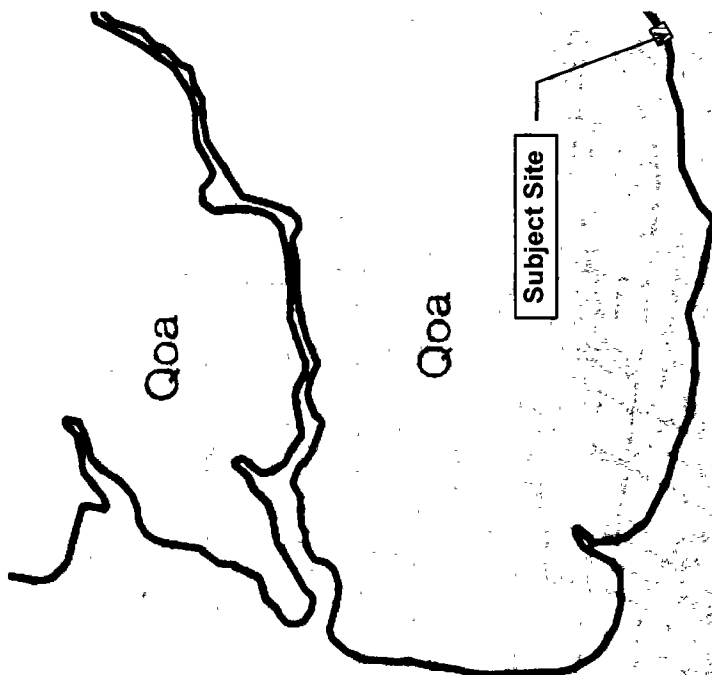
The native alluvial soil underlying the debris fill in all 3 exploratory borings is part of the Quaternary-age older alluvium (CDMG, 1998) that is characterized with alternating beds of medium dense to very dense sand and silt, with some clay. Figure 2, Local Geologic Map, depicts the distribution of different geologic materials in the vicinity of the Site. In specific, site native alluvial soils were found to be damp to moist and medium dense to very dense, consisting predominantly of gray/light gray to light olive/yellowish brown fine to medium-grained clean sands, silty sand with gravel, sandy silt with clay, and clayey silt.
